Hydrocarbon Fuel/Combustion- Chamber-Liner Materials Compatibility

Contract NAS 3-25070
Interim Final Report
NASA CR-185203
April 1990

Report No. KBQ-FR-1
NASA CR-185203

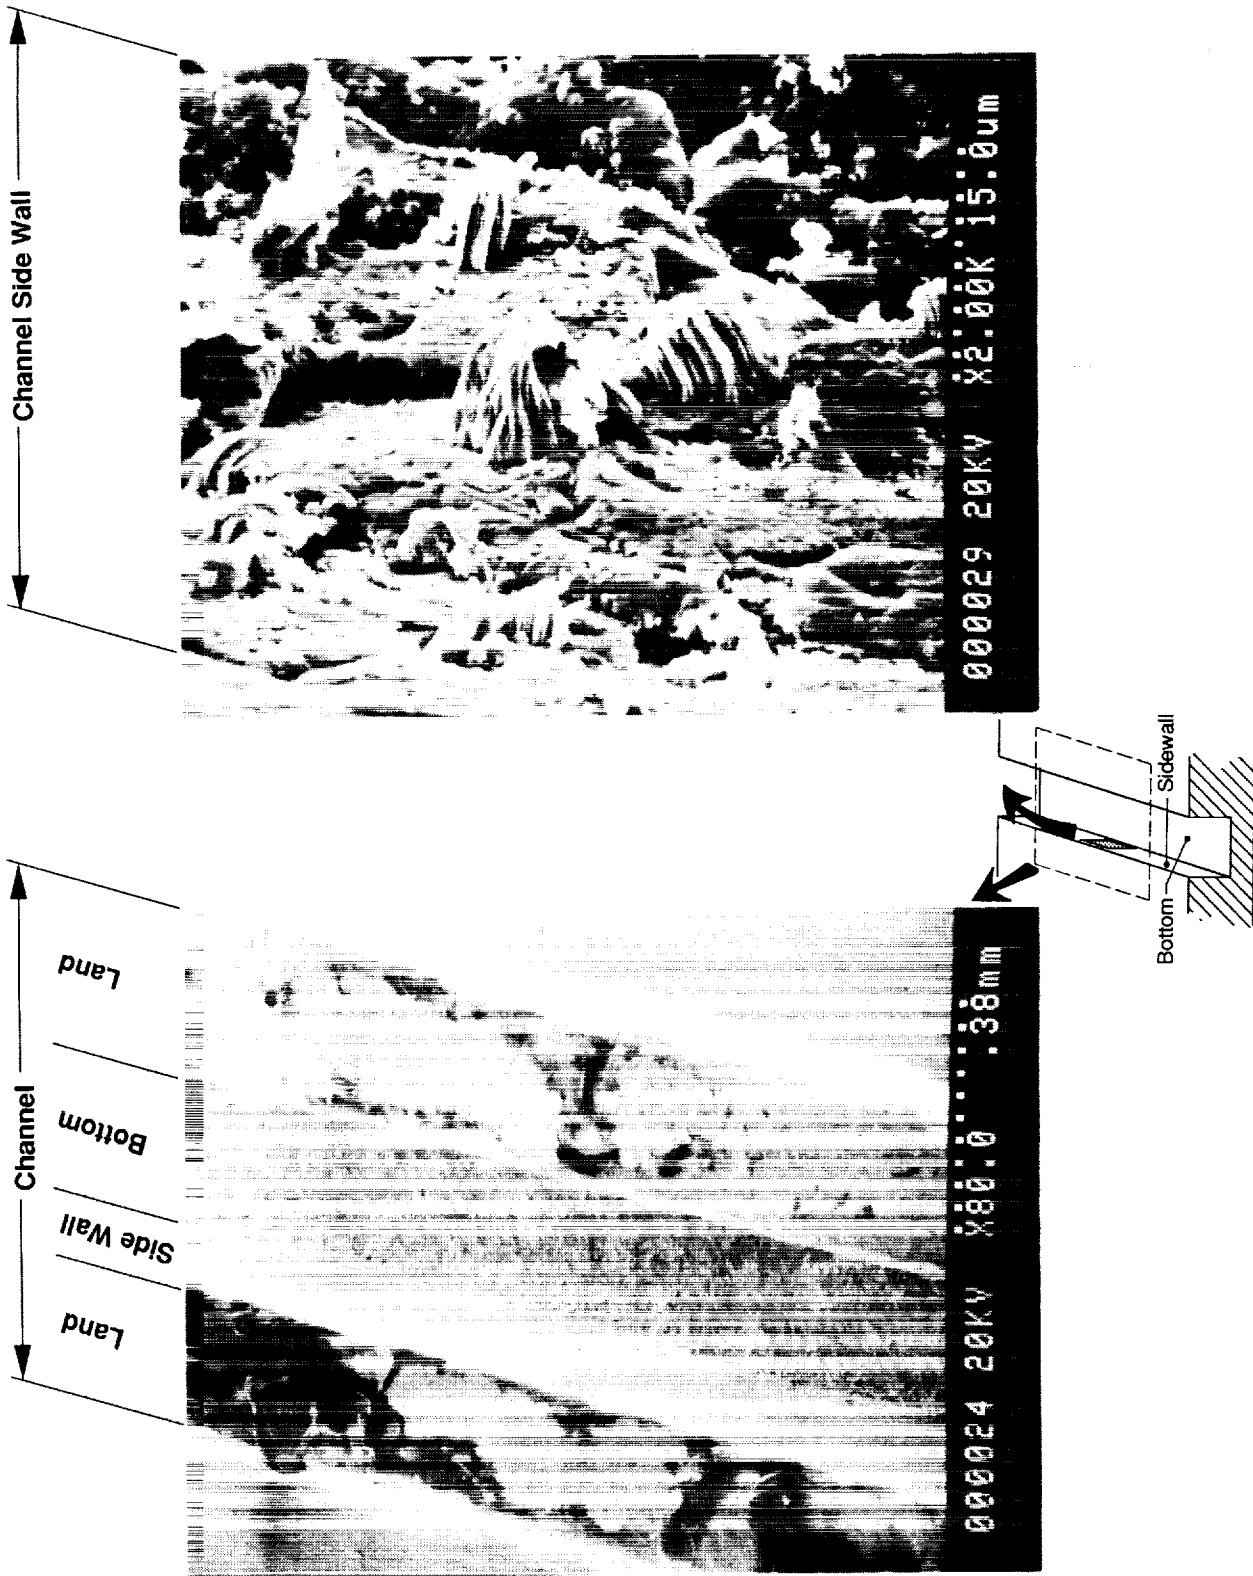
Figure 2. Addition of 50 ppm Sulfur to RP-1 Resulted in Corrosion of NASA-Z Channel, Even at Low Wall Temperature (586°F)

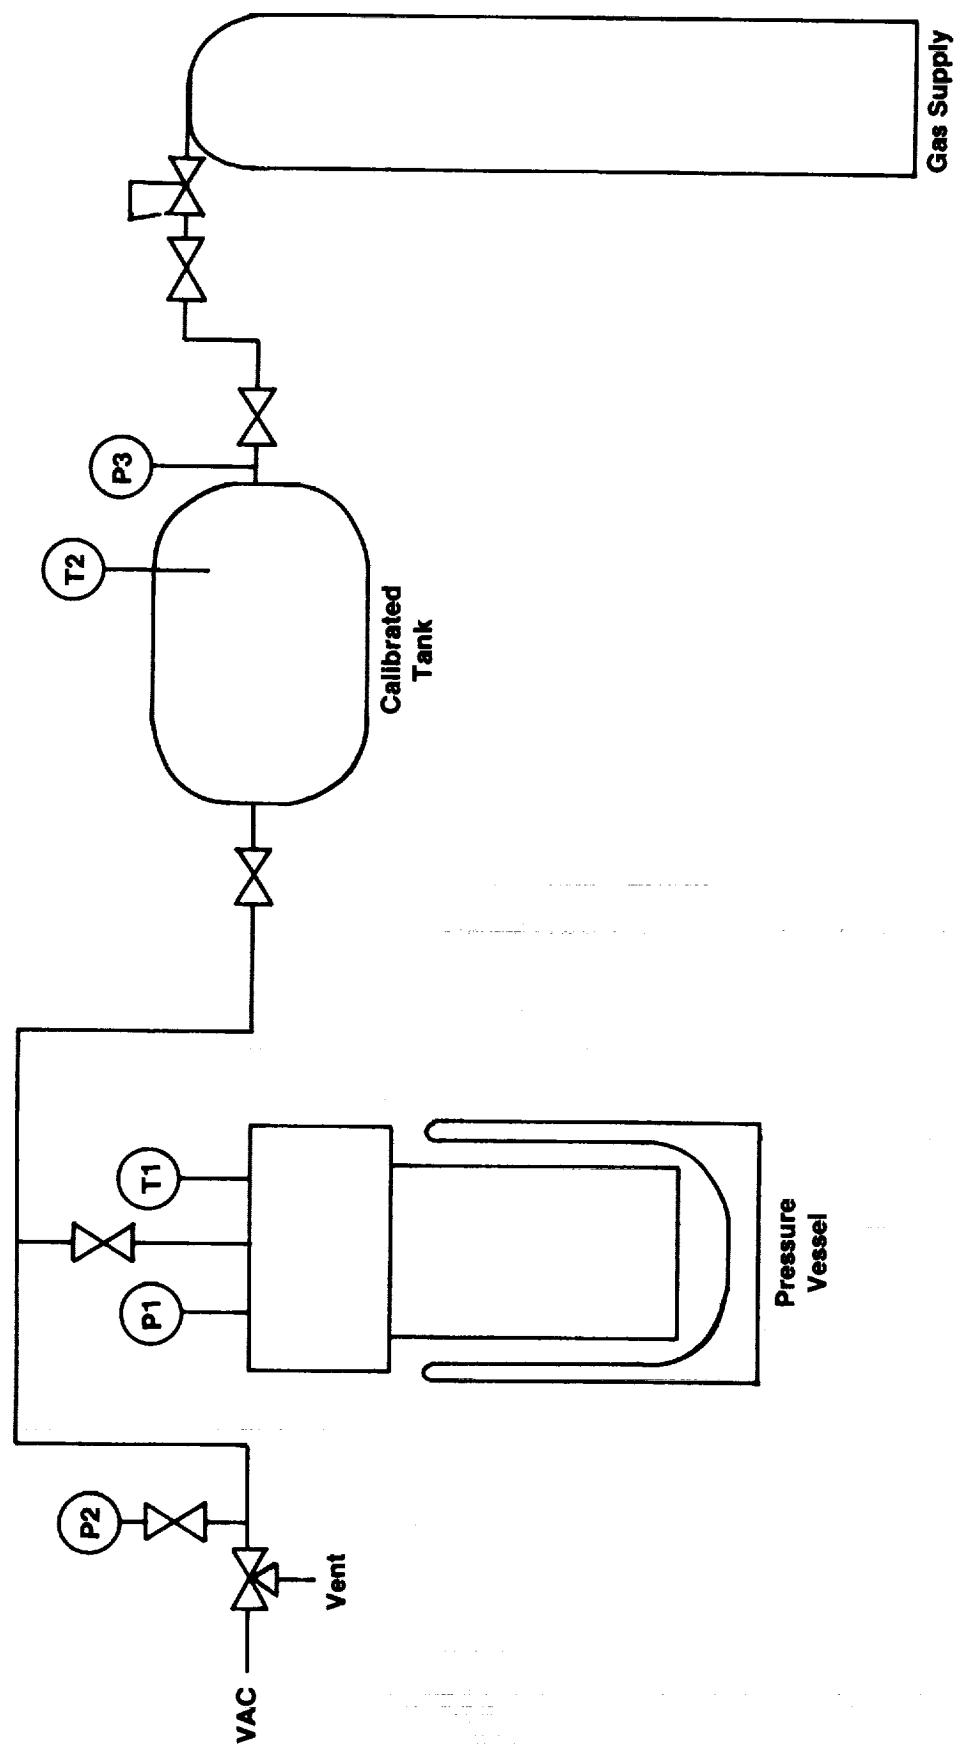
Figure 9. Bomb Loading Apparatus Used in Methane and Propane Static Tests

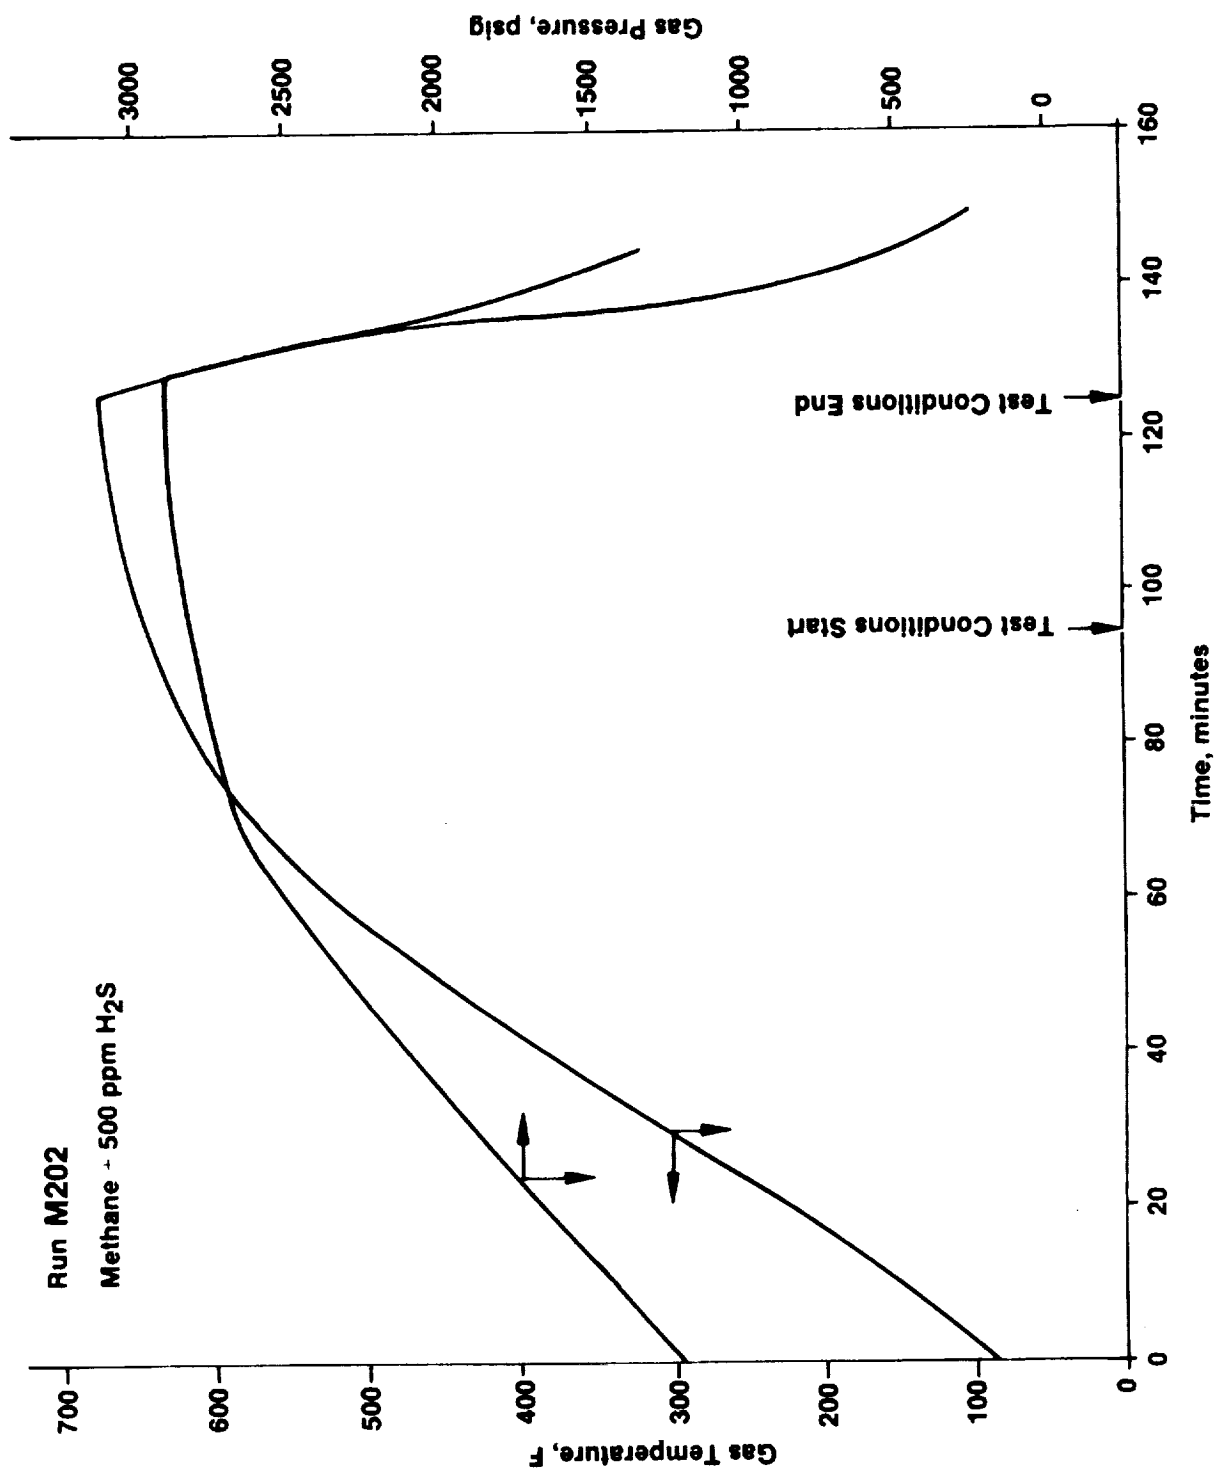
Figure 10. Typical Static Bomb Test Pressure and Temperature Traces

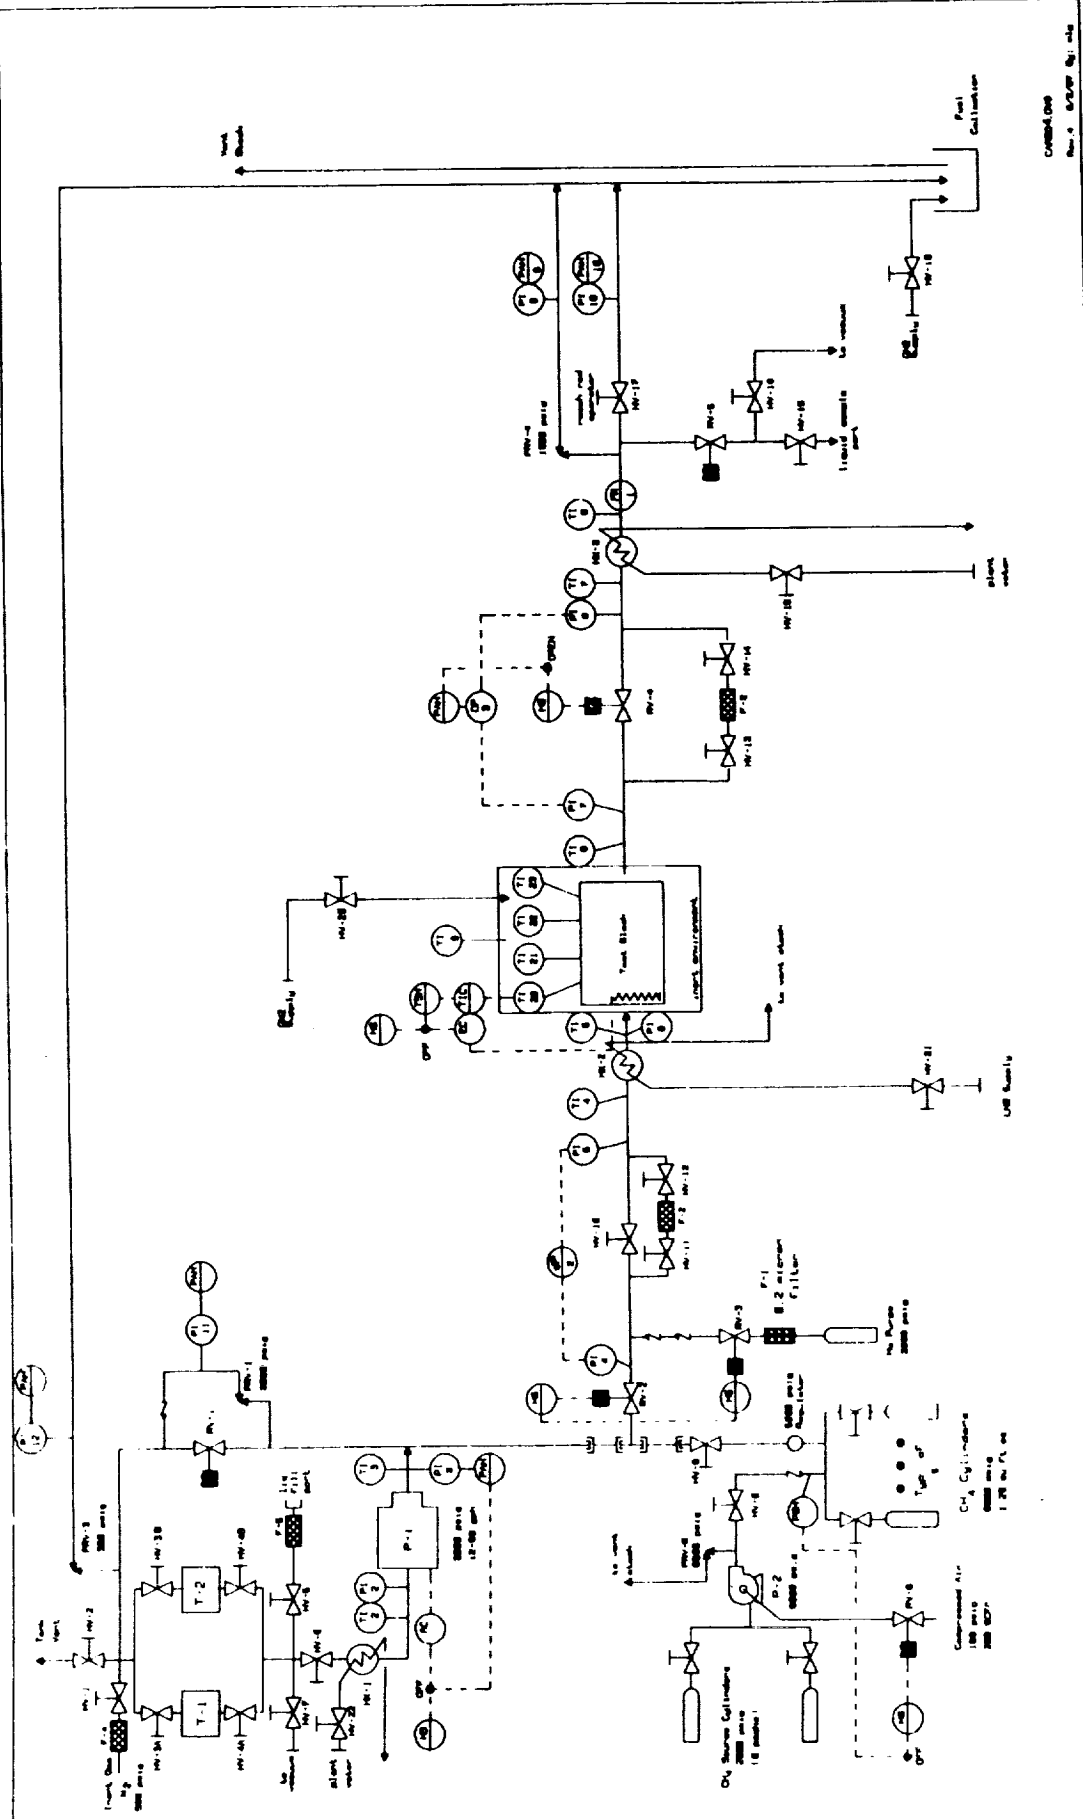
Figure 11. Schematic of Aerojet Carbothermal Test Facility

The apparatus incorporates two fuel delivery subsystems, one for high-pressure methane, the other for RP-1, n-dodecane, and propane. The RP-1 and n-dodecane were tested at ambient temperature inlet conditions. The methane and propane were subcooled to between -200 and -100 F enroute to the heated copper test specimen. The test specimen was heated within the Aerojet Carbothermal Materials Tester without the use of direct ohmic heating. The apparatus incorporates appropriate filters, thermocouples, pressure transducers, propellant thermal conditioners, and mass flowmeters to control and measure the test conditions and record the test data on-line. A port is incorporated to provide on-line fuel samples for chemical analysis.

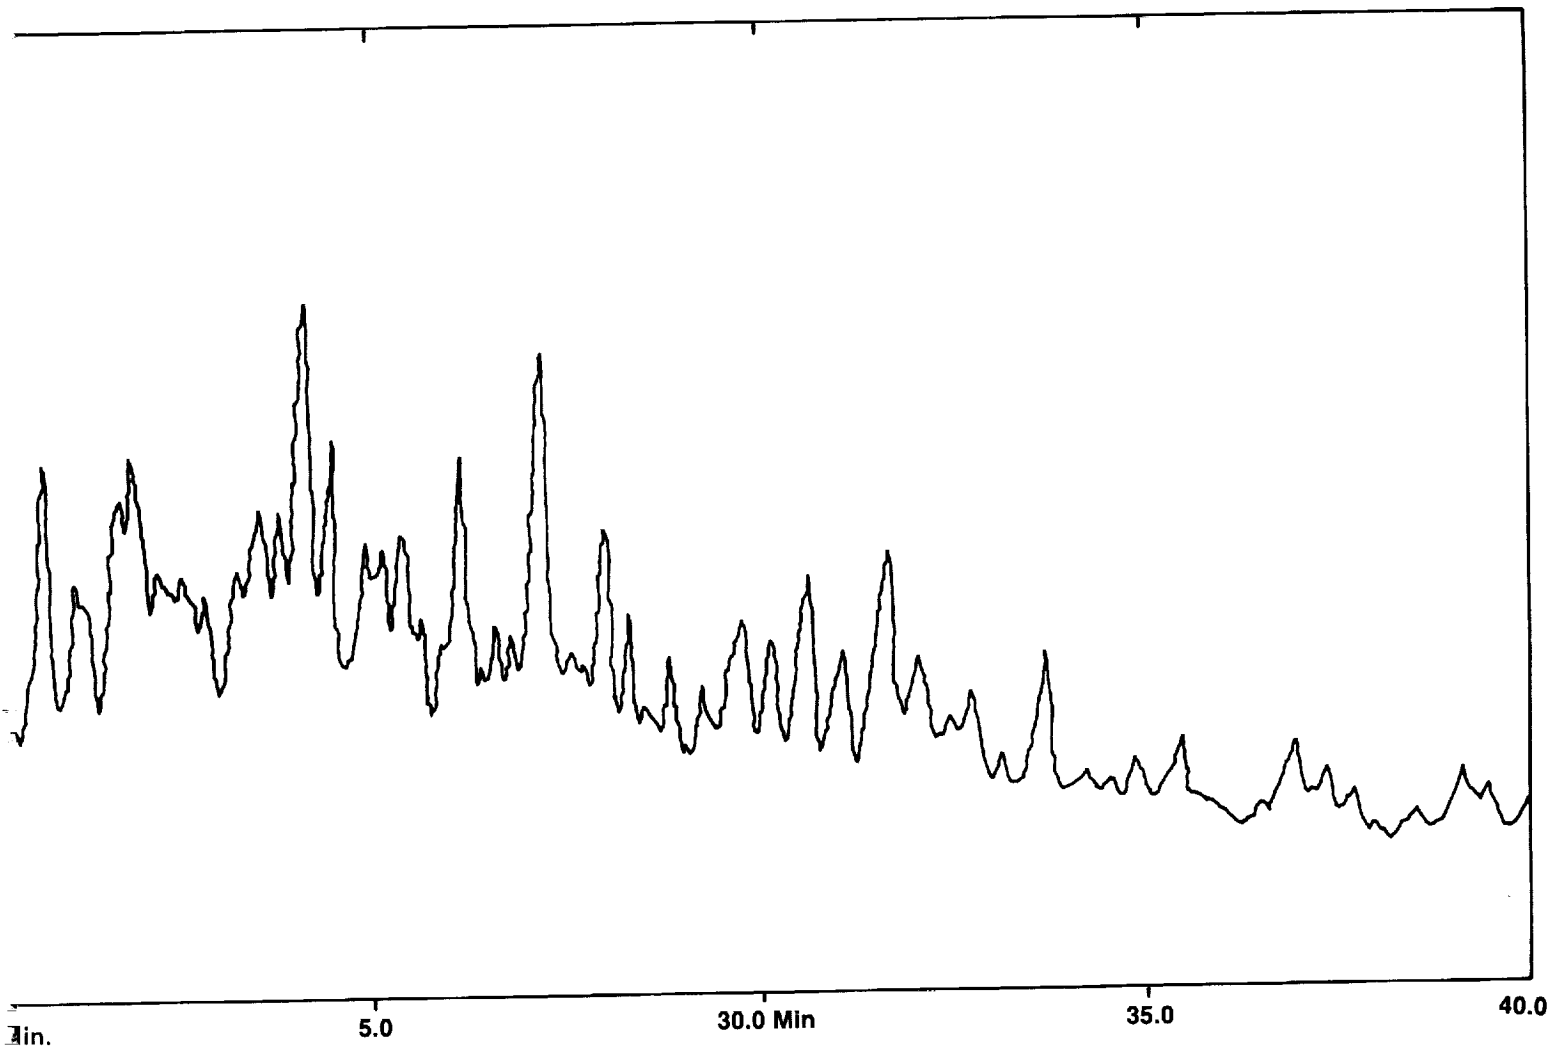
Figure 15. Gas Chromatograph of RP-1 After Ampul Tests

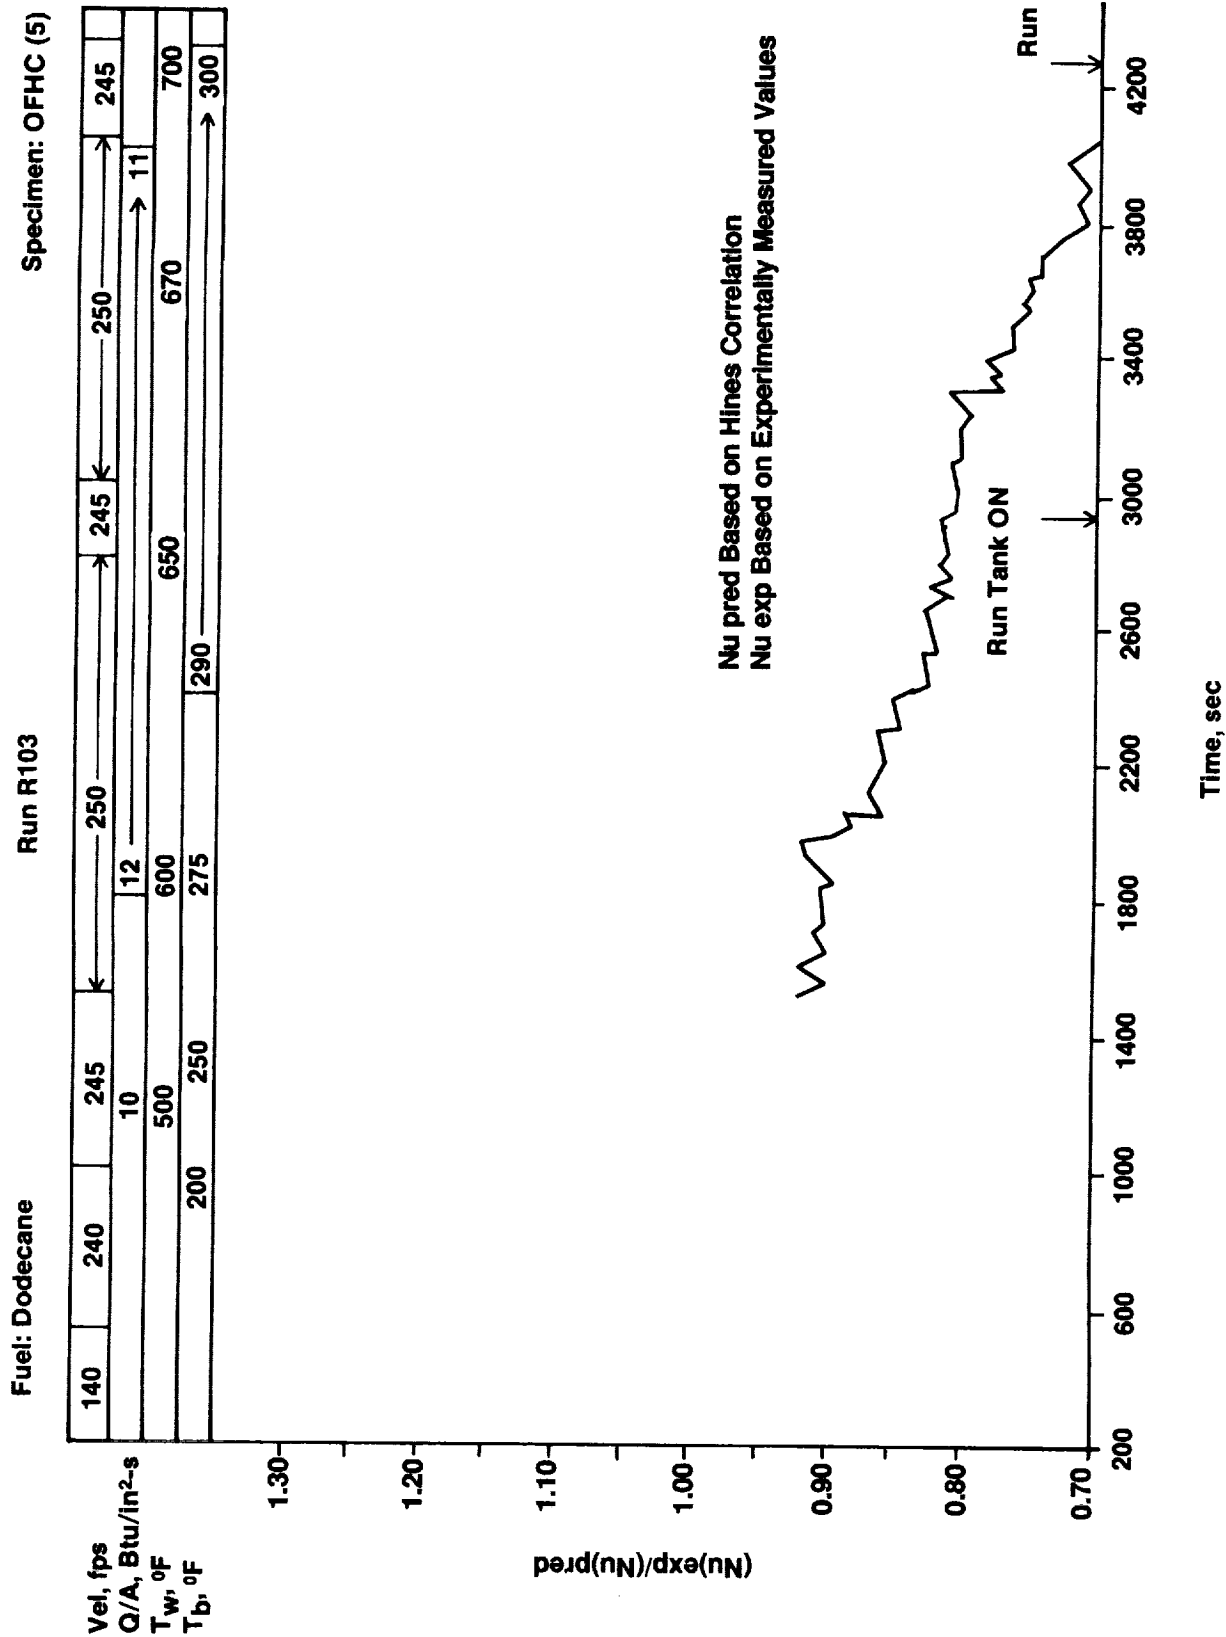
Figure 20. The Heat Transfer Coefficient of the Cooling Channel Decreased Steadily During Run R103

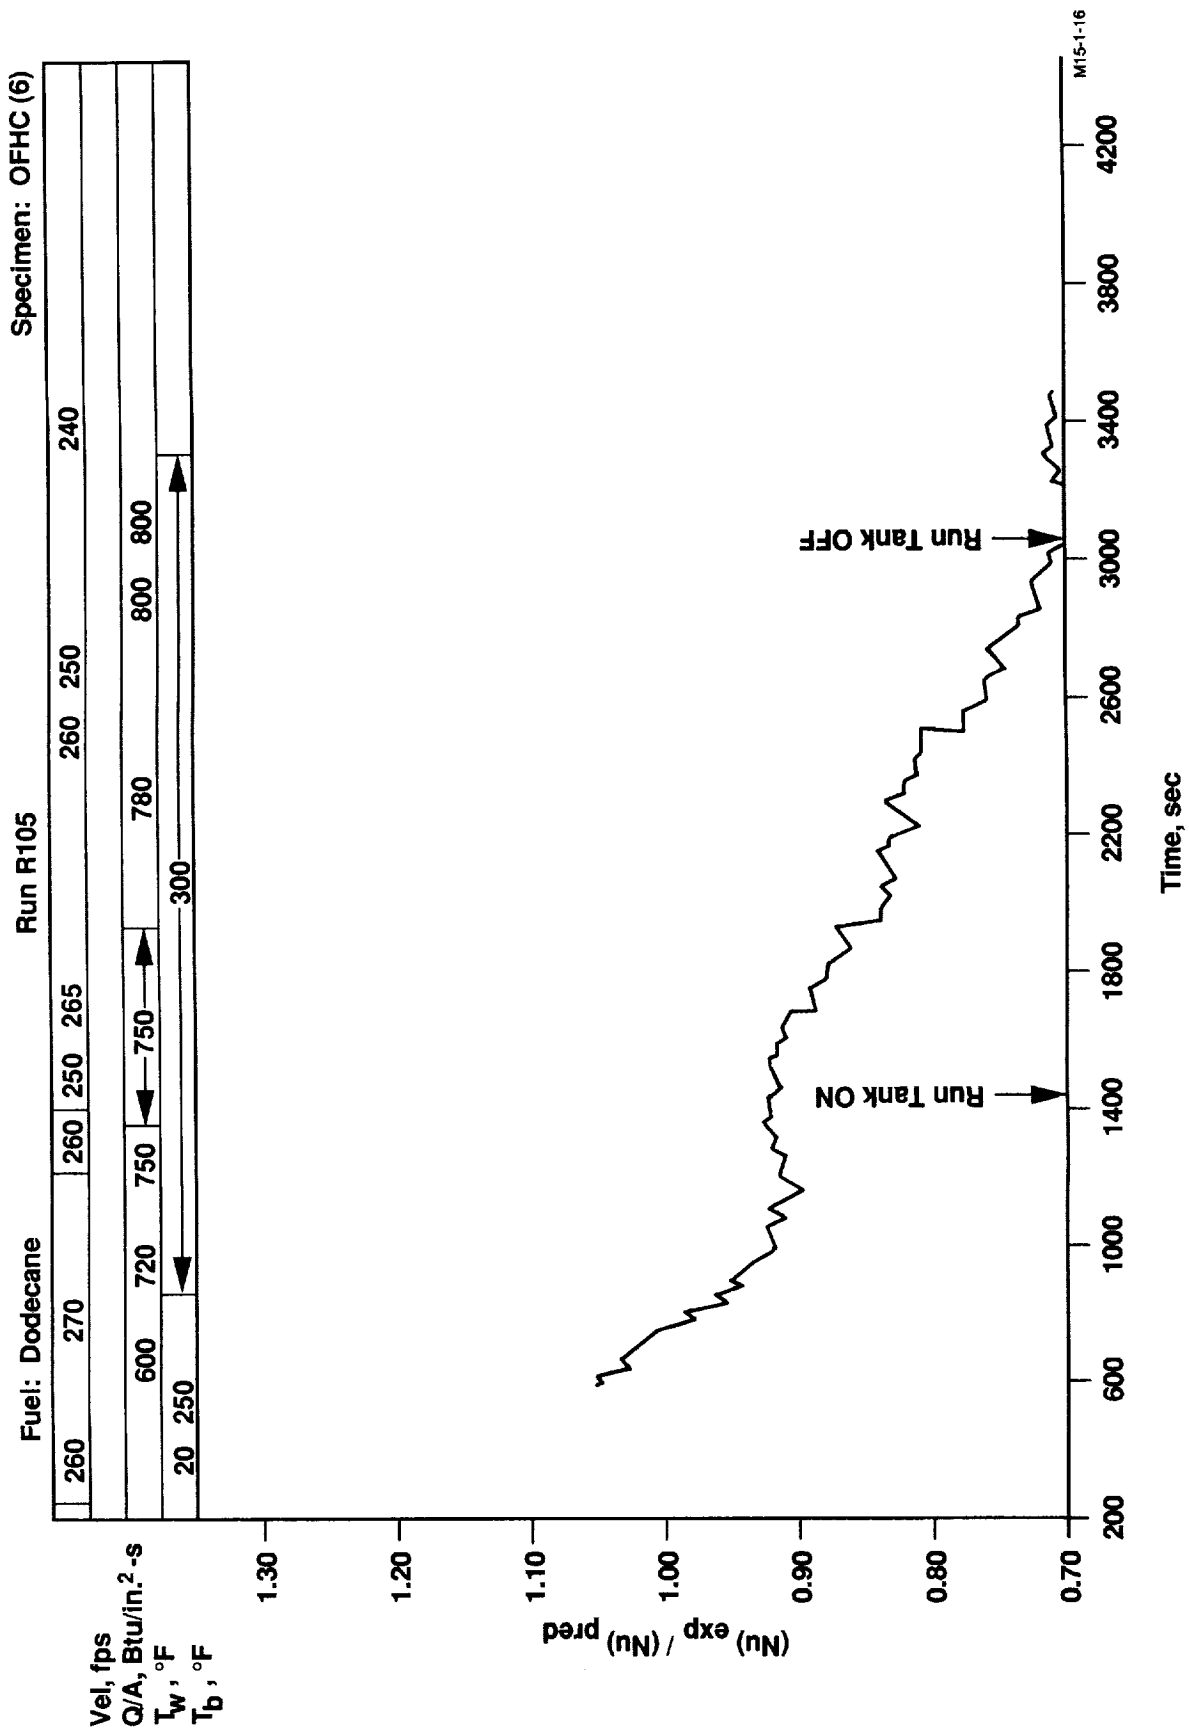
Figure 22. The Heat Transfer Coefficient of Cooling Channel Decreased Rapidly at High Wall Temperature During Run R105

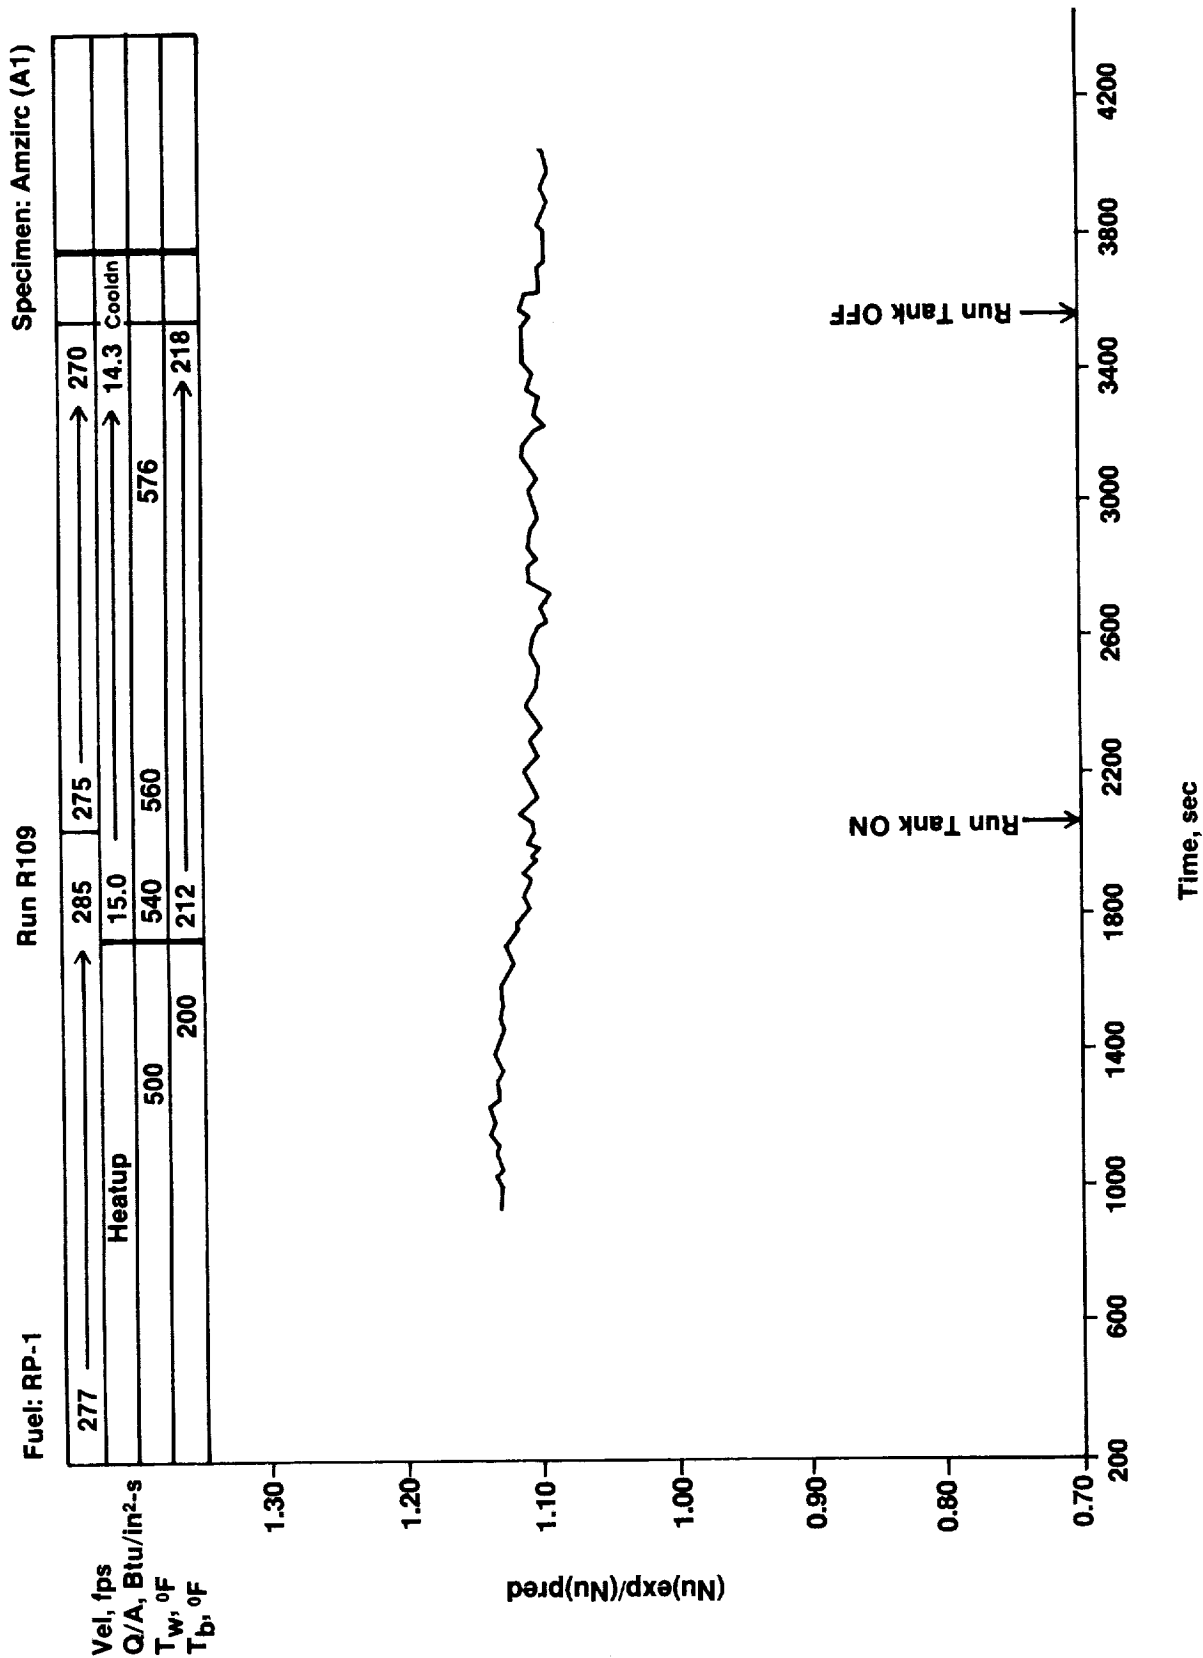
Figure 24. Operation at Lower Wall Temperatures Led to Almost Steady Heat Transfer Performance of Cooling Channel During Run R109

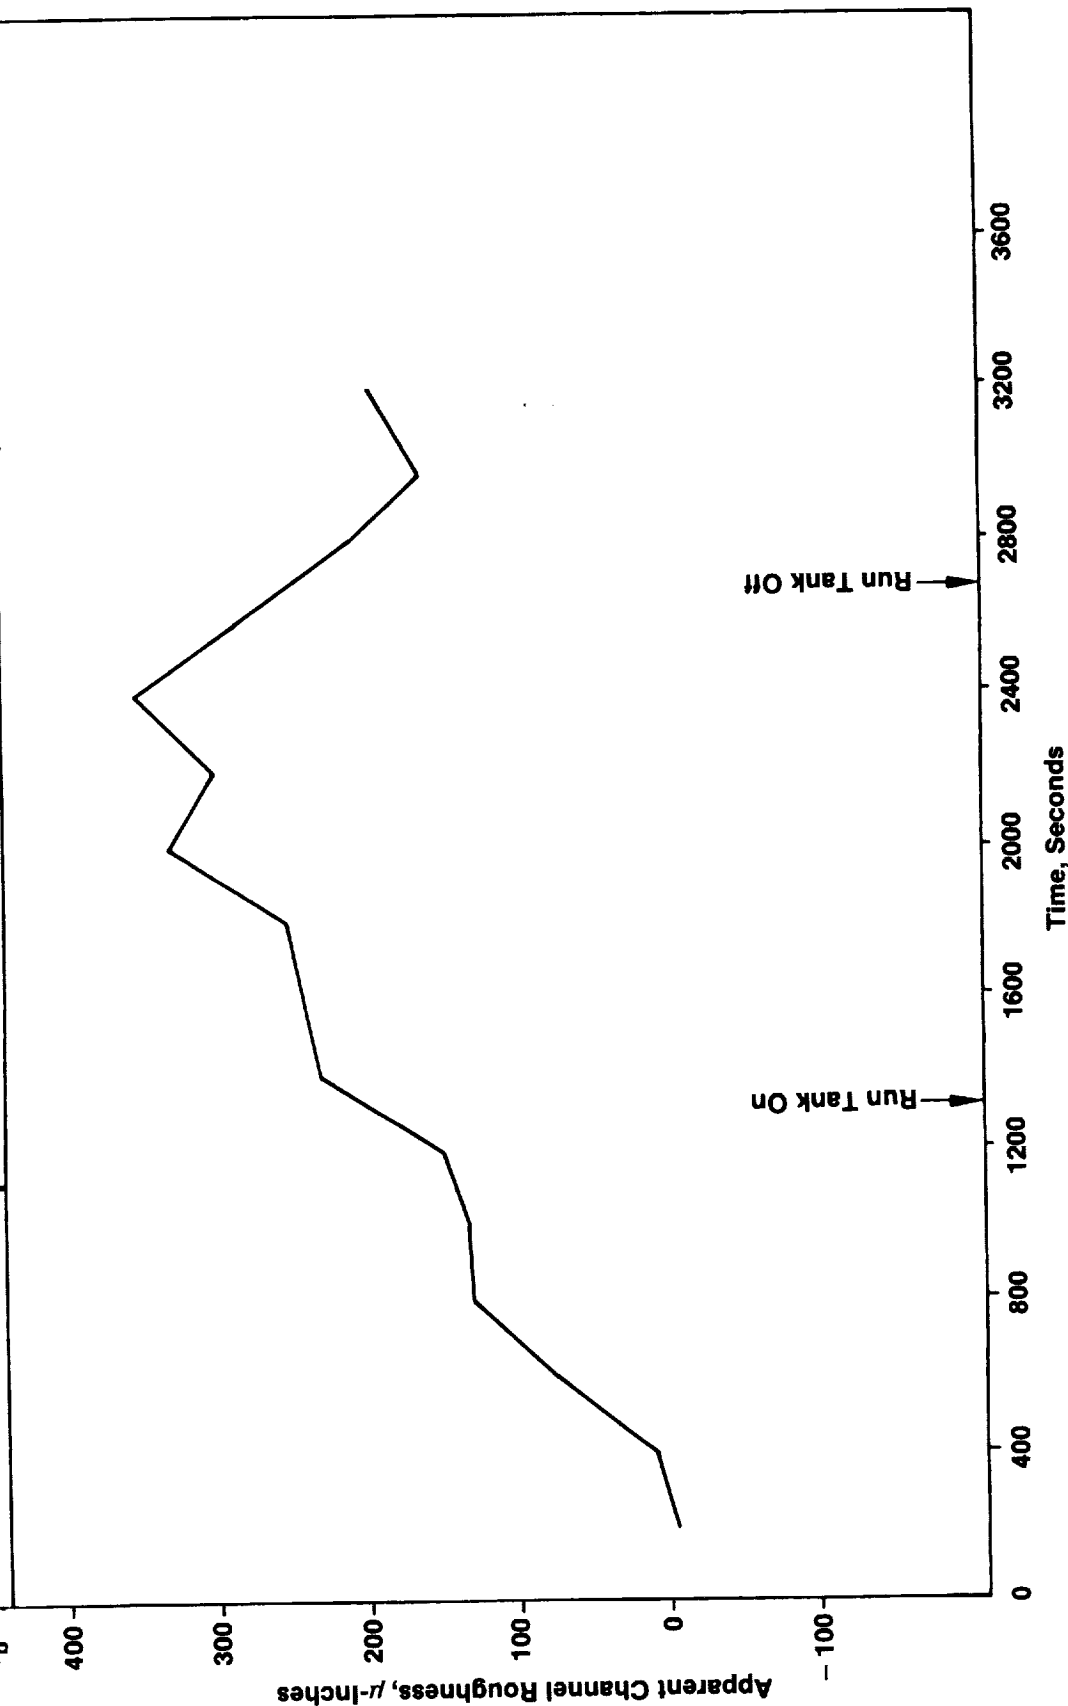
Figure 25. The Apparent Channel Roughness Increased Significantly During Run R111

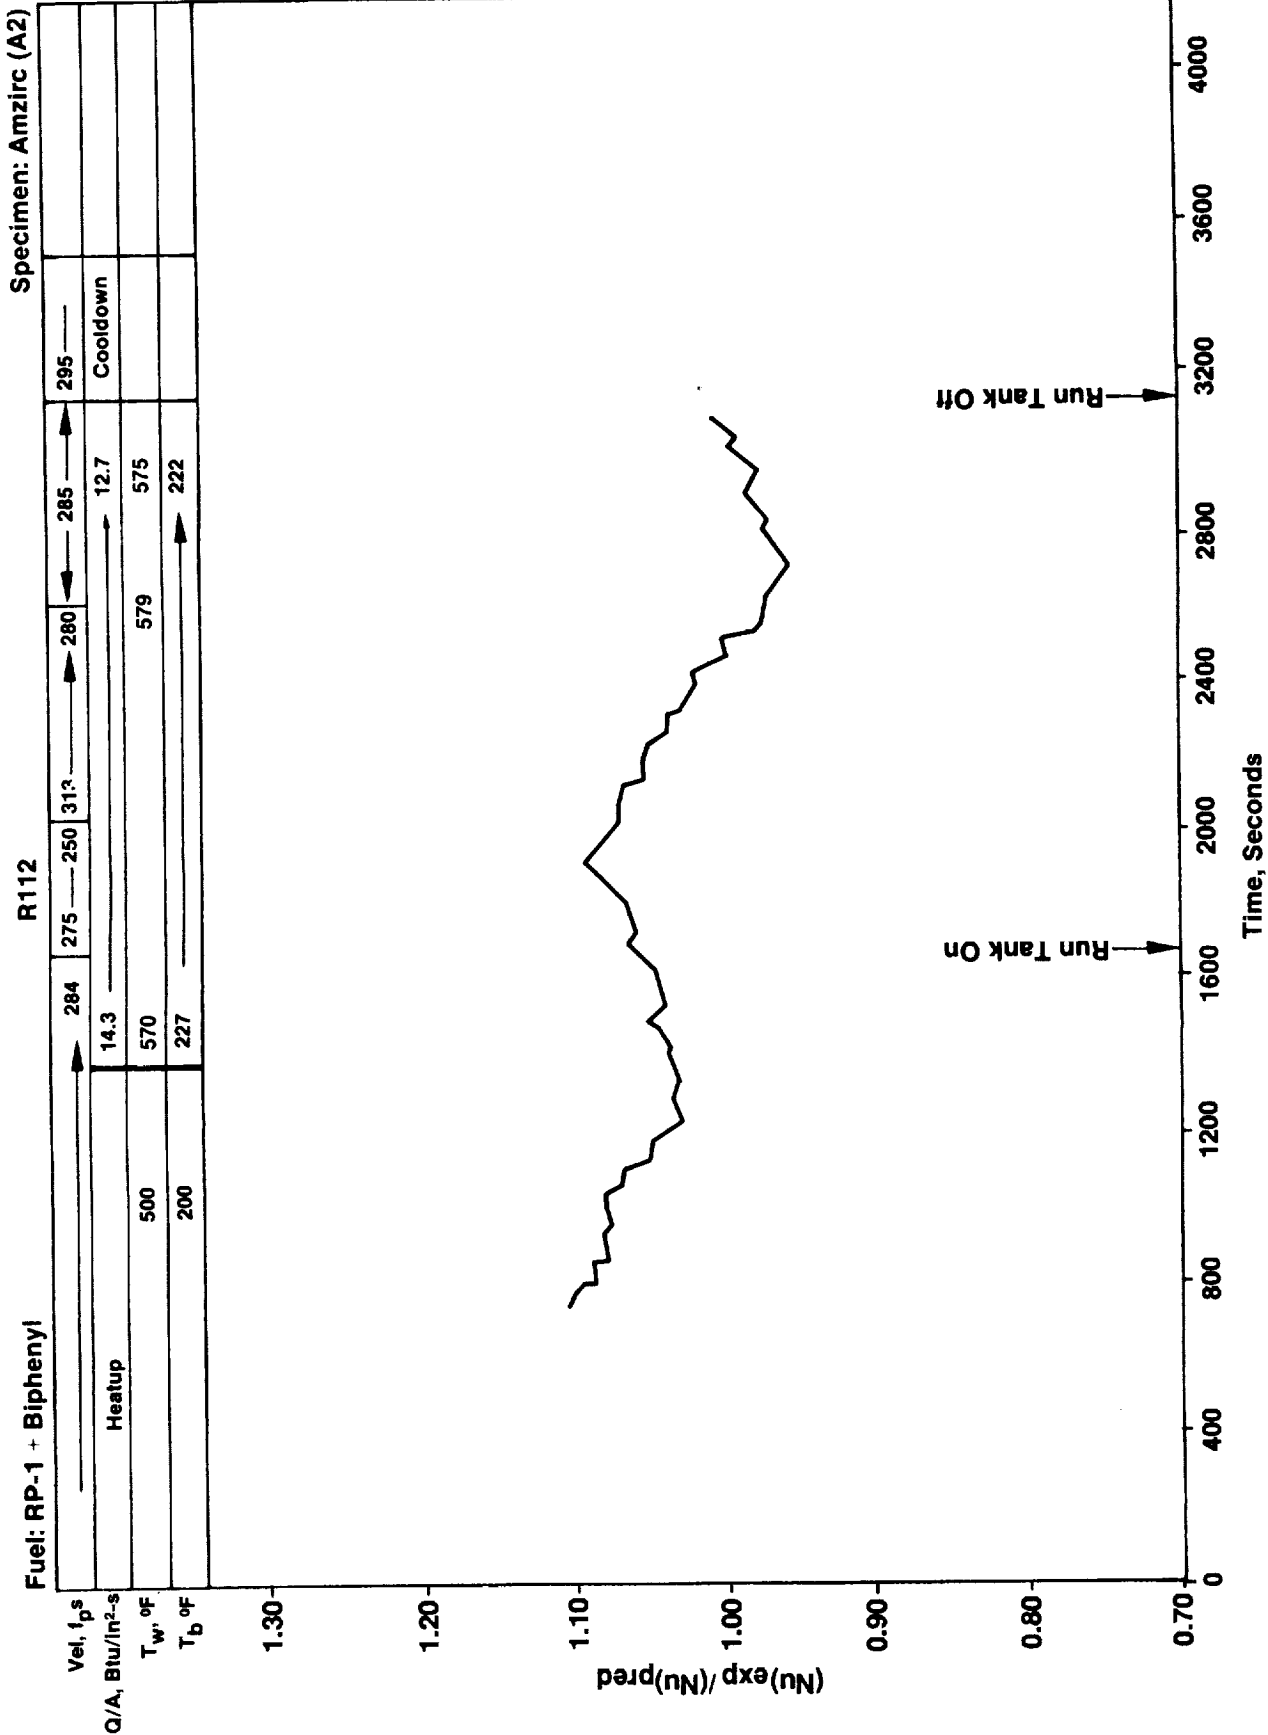
Figure 26. Heat Transfer Coefficient of Cooling Channel During Run R112

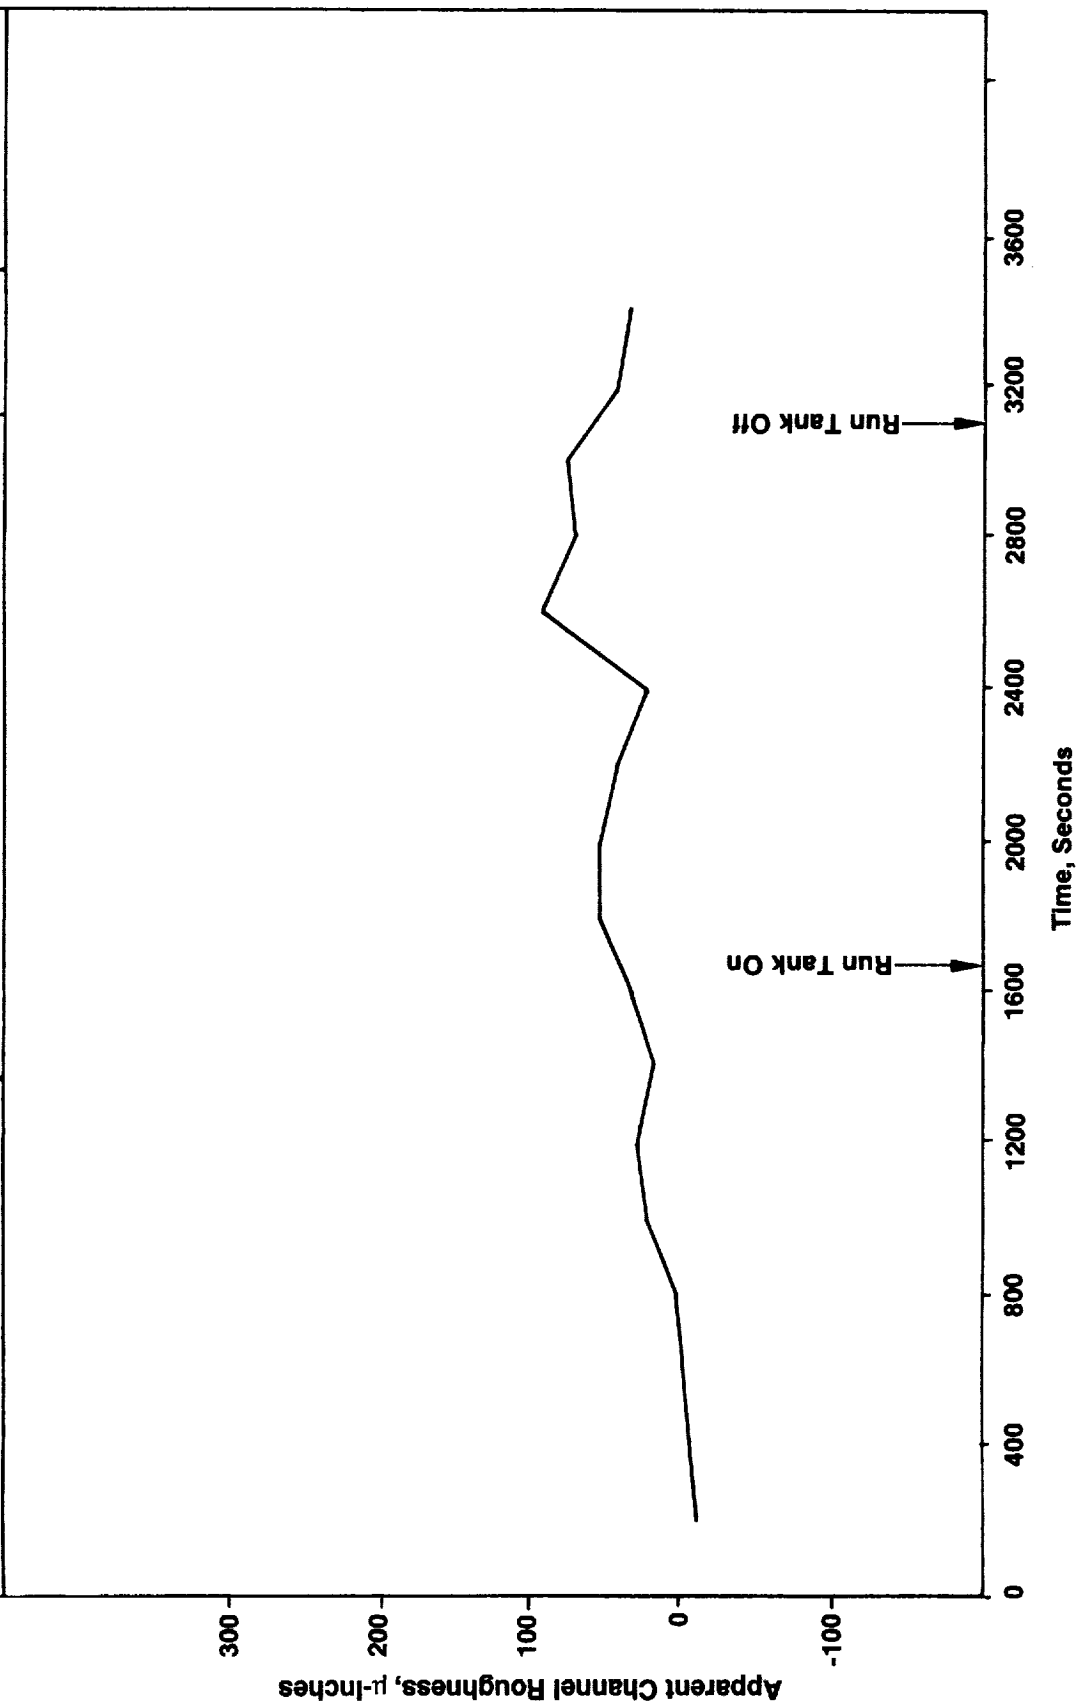
Figure 27. The Apparent Channel Roughness During Run R112 Increased Slightly

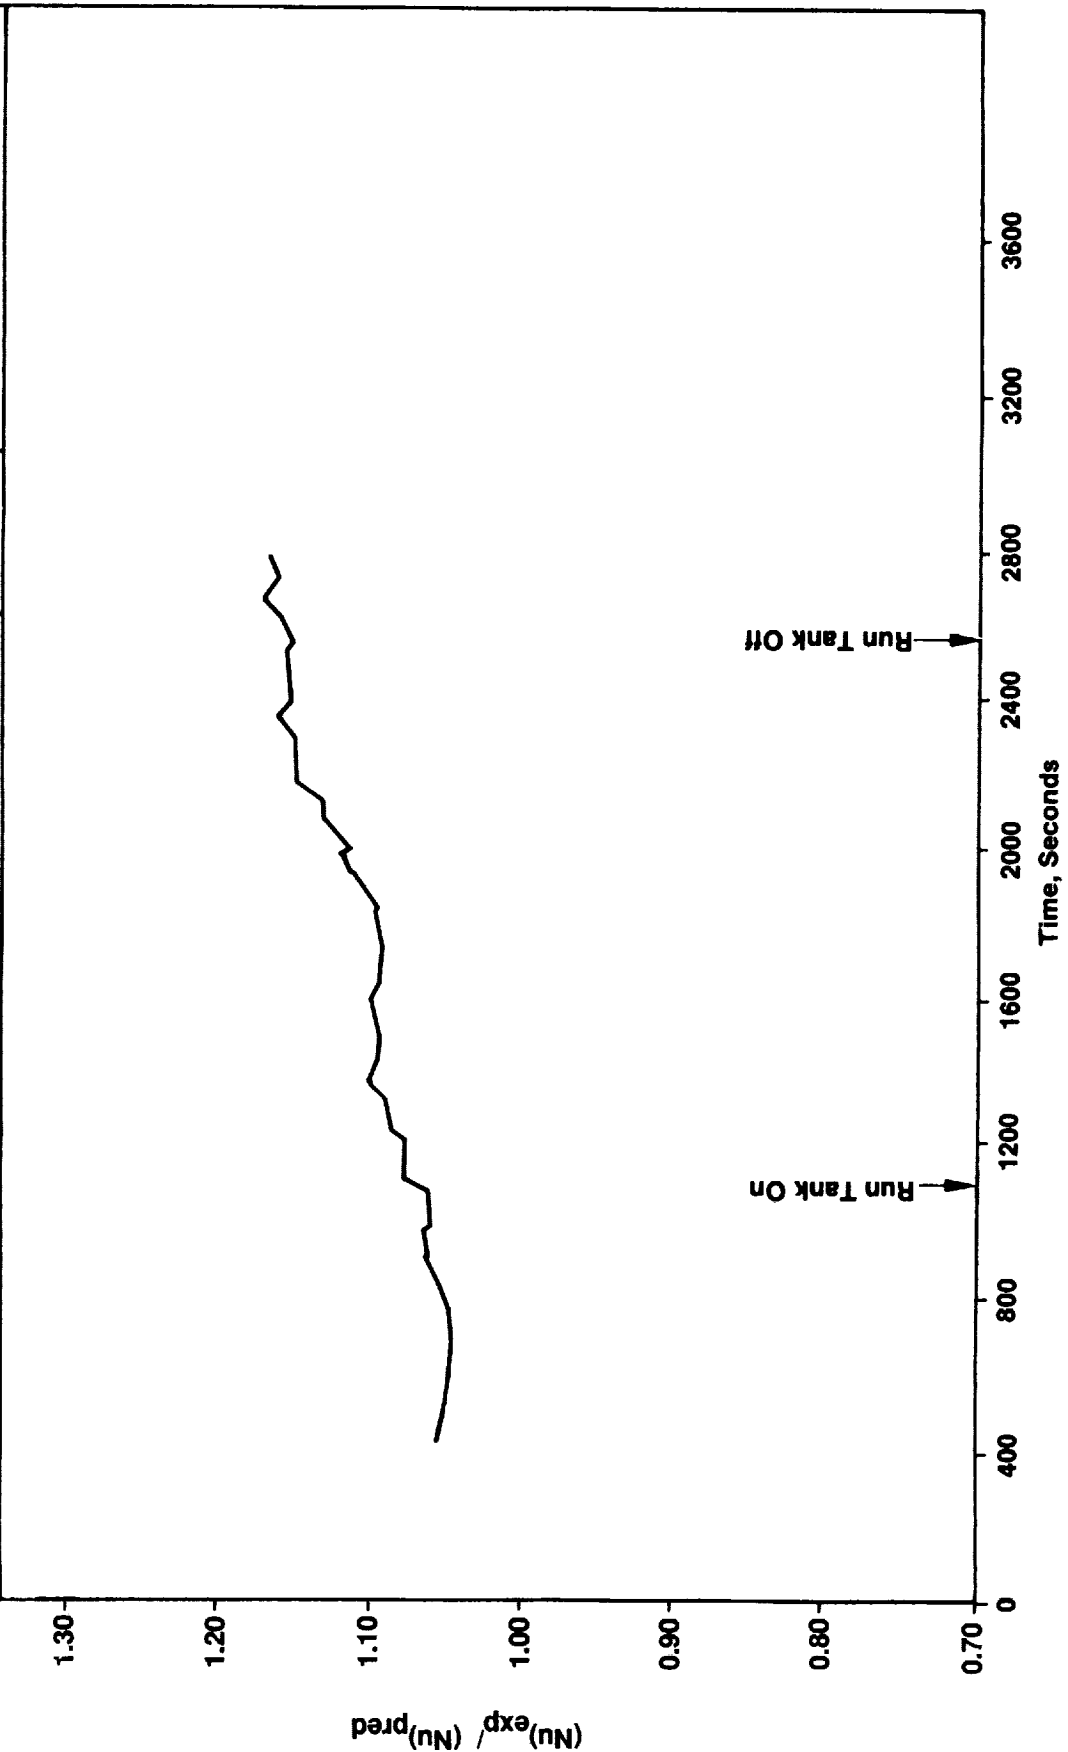
Figure 28. Heat Transfer Coefficient of Cooling Channel Increased Slightly During Run R113, Possibly due to Roughening of the Channel Walls
